The Apollo 13 accident, which aborted man's third mission to explore the surface of the Moon, is a harsh reminder of the immense difficulty of this undertaking.

The Apollo 13 Review Board was charged with the responsibilities of reviewing the circumstances surrounding the accident, of establishing the probable causes of the accident, of assessing the effectiveness of flight recovery actions, of reporting these findings, and of developing recommendations for corrective or other actions. The Board has made every effort to carry out its assignment in a thorough, objective, and impartial manner. In doing so, the Board made effective use of the failure analyses and corrective action studies carried out by the Manned Spacecraft Center and was very impressed with the dedication and objectivity of this effort.

# TABLE OF CONTENTS

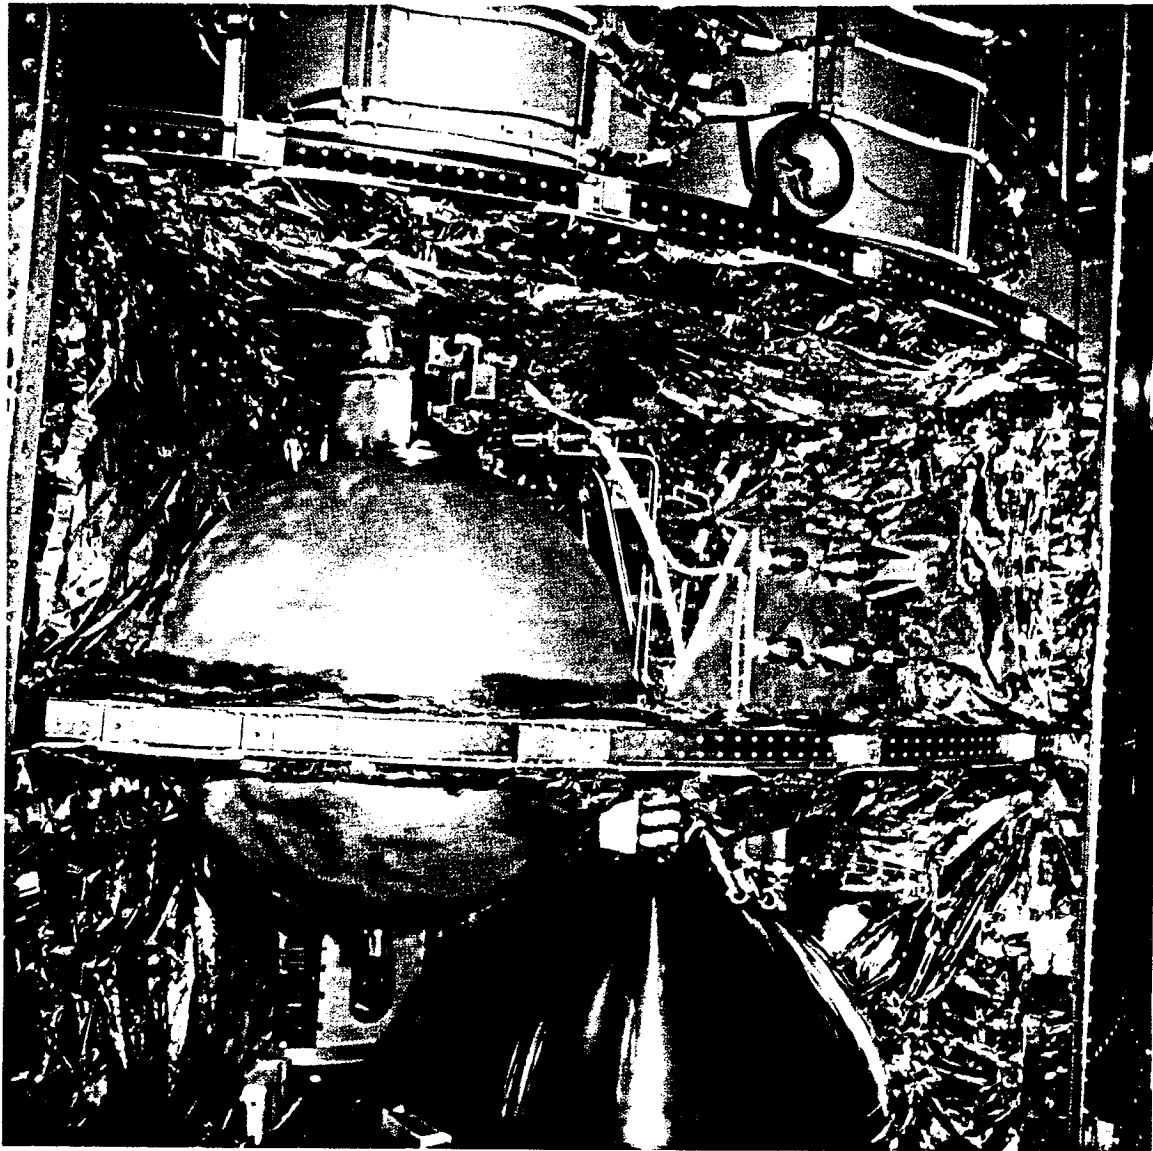
Figure 4-6.- Oxygen tank shelf.

Two oxygen tanks are mounted on a shelf in bay 4 of the SM, as shown in figure 4-4. Figures 4-5 through 4-8 are photographs of portions

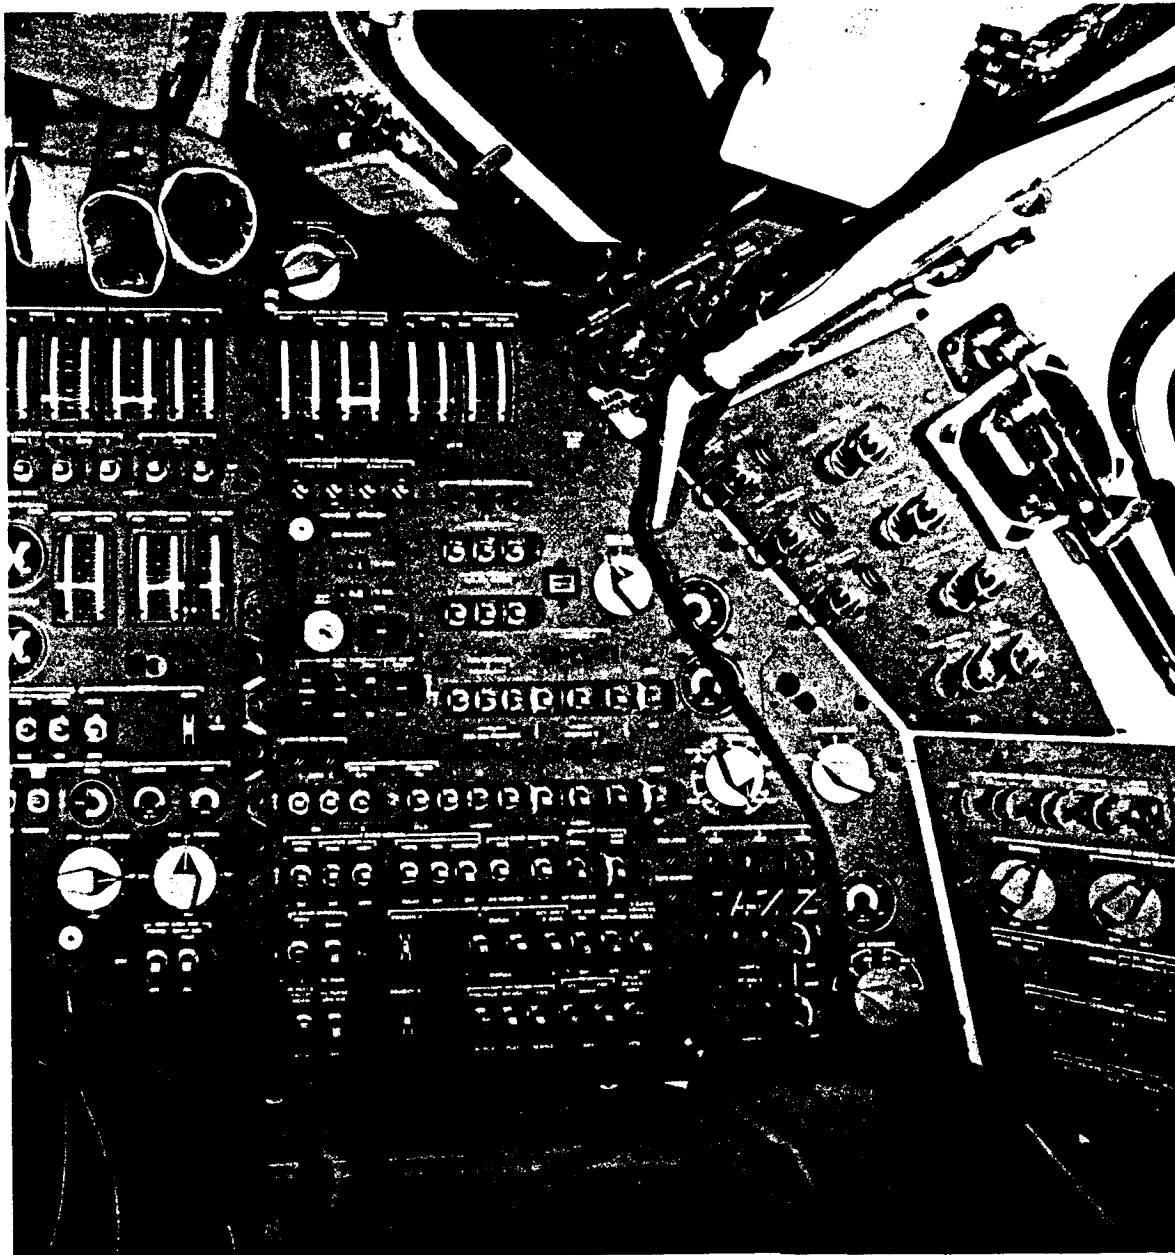
Figure 4-13.- Main display panel.

The Lunar Module Pilot was in the tunnel between the CSM and the LM, returning to the CSM. The Command Module Pilot was in the left-hand couch, monitoring spacecraft performance. Because of the master alarm indicating low voltage, the CMP moved across to the right-hand couch where CSM voltages can be observed. He reported that voltages were "looking good" at 55:56:10. At this time, main bus B had recovered and fuel cell 3 did not fail for another 1-1/2 minutes. He also reported fluctuations in the oxygen tank no. 2 quantity, followed by a return to the off-scale high position. (See fig. 4-13 for CM panel arrangement).

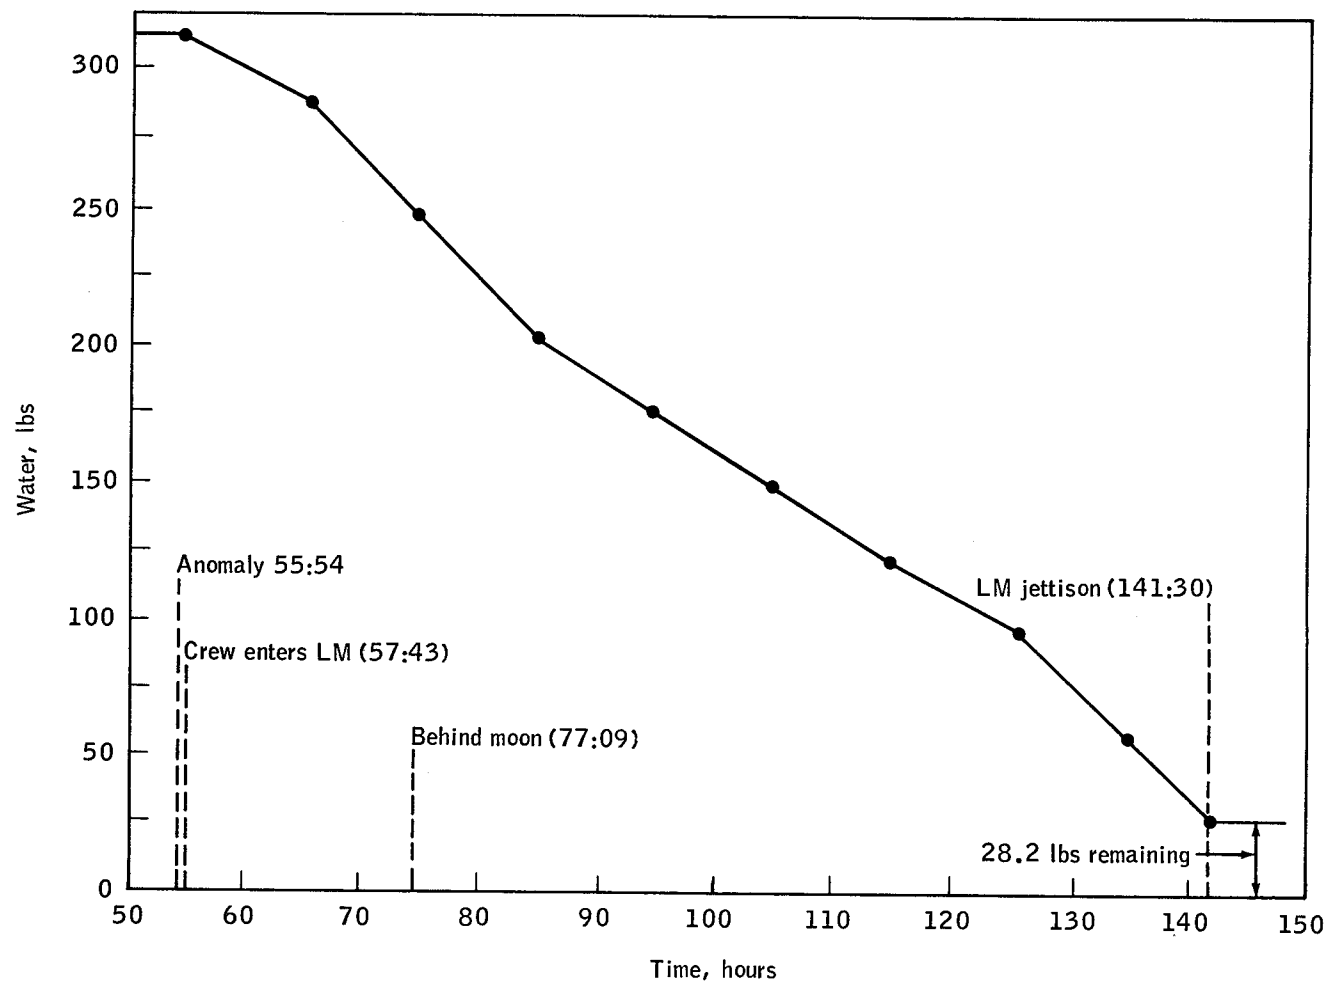
Figure 4-17.- Usable remaining water.

The most critical consumables were water, used to cool the CSM and LM systems during use; CSM and LM battery power, the CSM batteries being for use during reentry and the LM batteries being needed for the rest of the mission; LM oxygen for breathing; and lithium hydroxide (LiOH) filter cannisters used to remove carbon dioxide from the spacecraft cabin atmosphere. These consumables, and in particular the water and LiOH cannisters, appeared to be extremely marginal in quantity shortly after the accident, but once the LM was powered down to conserve electric power and to generate less heat and thus use less water, the situation improved greatly. Engineers at MSC developed a method which allowed the crew to use materials on board to fashion a device allowing use of the CM LiOH cannisters in the LM cabin atmosphere cleaning system (see fig. 4-16). At splashdown, many hours of each consumable remained available (see figs. 4-17 through 4-19 and table 4-III).
